Indicative test Report No. 20576A

Tilcor Bond

Test methods for external fire exposure to roofs: Test 4: Method with two stages incorporating burning brands, wind and supplementary radiant heat, according to CEN/TS 1187:2012: Test 4.

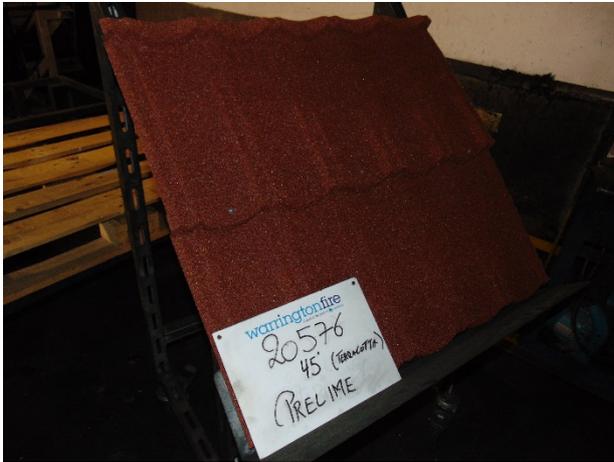
A-1': Before

Specimen No:	A-1'	A-2'
Duration of flaming after withdrawal of the test flame (min:sec)	00:00	00:00
Maximum flame spread distance (mm)	0	0
Time to fire penetration (min:sec)	Did not penetrate	Did not penetrate
Nature of the penetration	N.a.	N.a.

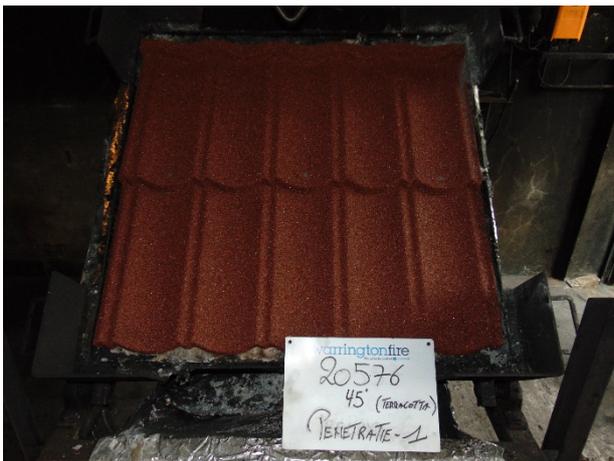
A-1: Before

Specimen No:	A-1	A-2	Average
Time to fire penetration (min:sec)	Did not penetrate	Did not penetrate	Did not penetrate
Nature of the penetration	N.a.	N.a.	N.a.
Additional observations: Panels did not ignite, carbonization Marked variability between the specimen: None
