Test Report No. 20576B

Tilcor Bond

Test methods for external fire exposure to roofs: Test 4: Method with two stages incorporating burning brands, wind and supplementary radiant heat, according to CEN/TS 1187:2012: Test 4.

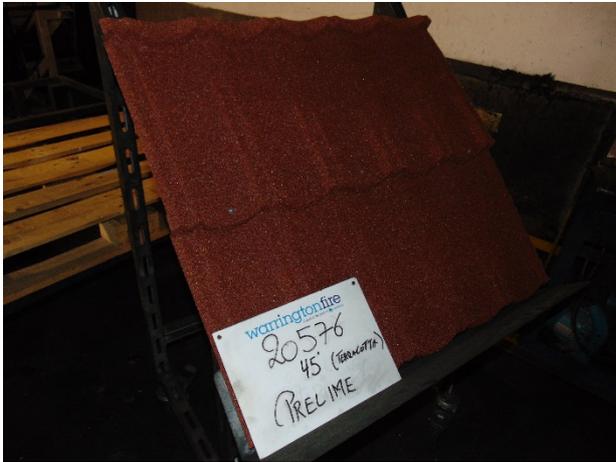
Preliminary: Before

Specimen No:	1
Duration of flaming after withdrawal of the test flame (min:sec)	00:00
Maximum flame spread distance (mm)	0
Time to fire penetration (min:sec)	Did not penetrate
Nature of the penetration	N.a.

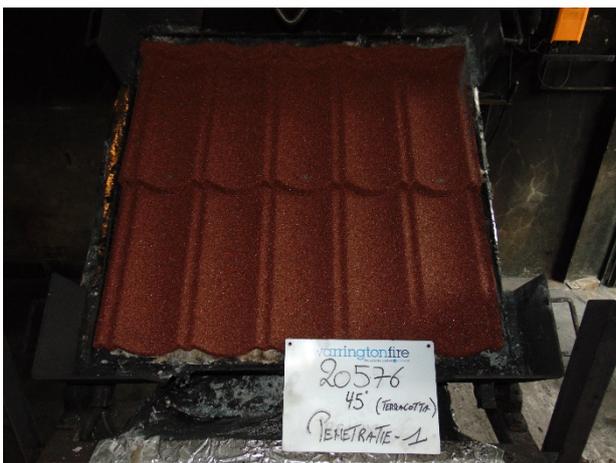
Penetration 1: Before

Specimen No:	2	3	4	Average
Time to fire penetration (min:sec)	Did not penetrate	Did not penetrate	Did not penetrate	Did not penetrate
Nature of the penetration	N.a.	N.a.	N.a.	N.a.
Additional observations: Panels did not ignite, carbonization Marked variability between the specimen: None
